**PRE-CAP MONITORING REPORT**  
**YARBORO PROPERTY**  
**2205 OAK HILL DRIVE**  
**GREENSBORO, NORTH CAROLINA**

**APRIL 2, 1997**

**LEGACY ENVIRONMENTAL SERVICES, INC.**

Reference: Pre-CAP Monitoring Report  
Yarboro Property  
2205 Oak Hill Drive  
Greensboro, North Carolina  
Groundwater Incident Number 10017

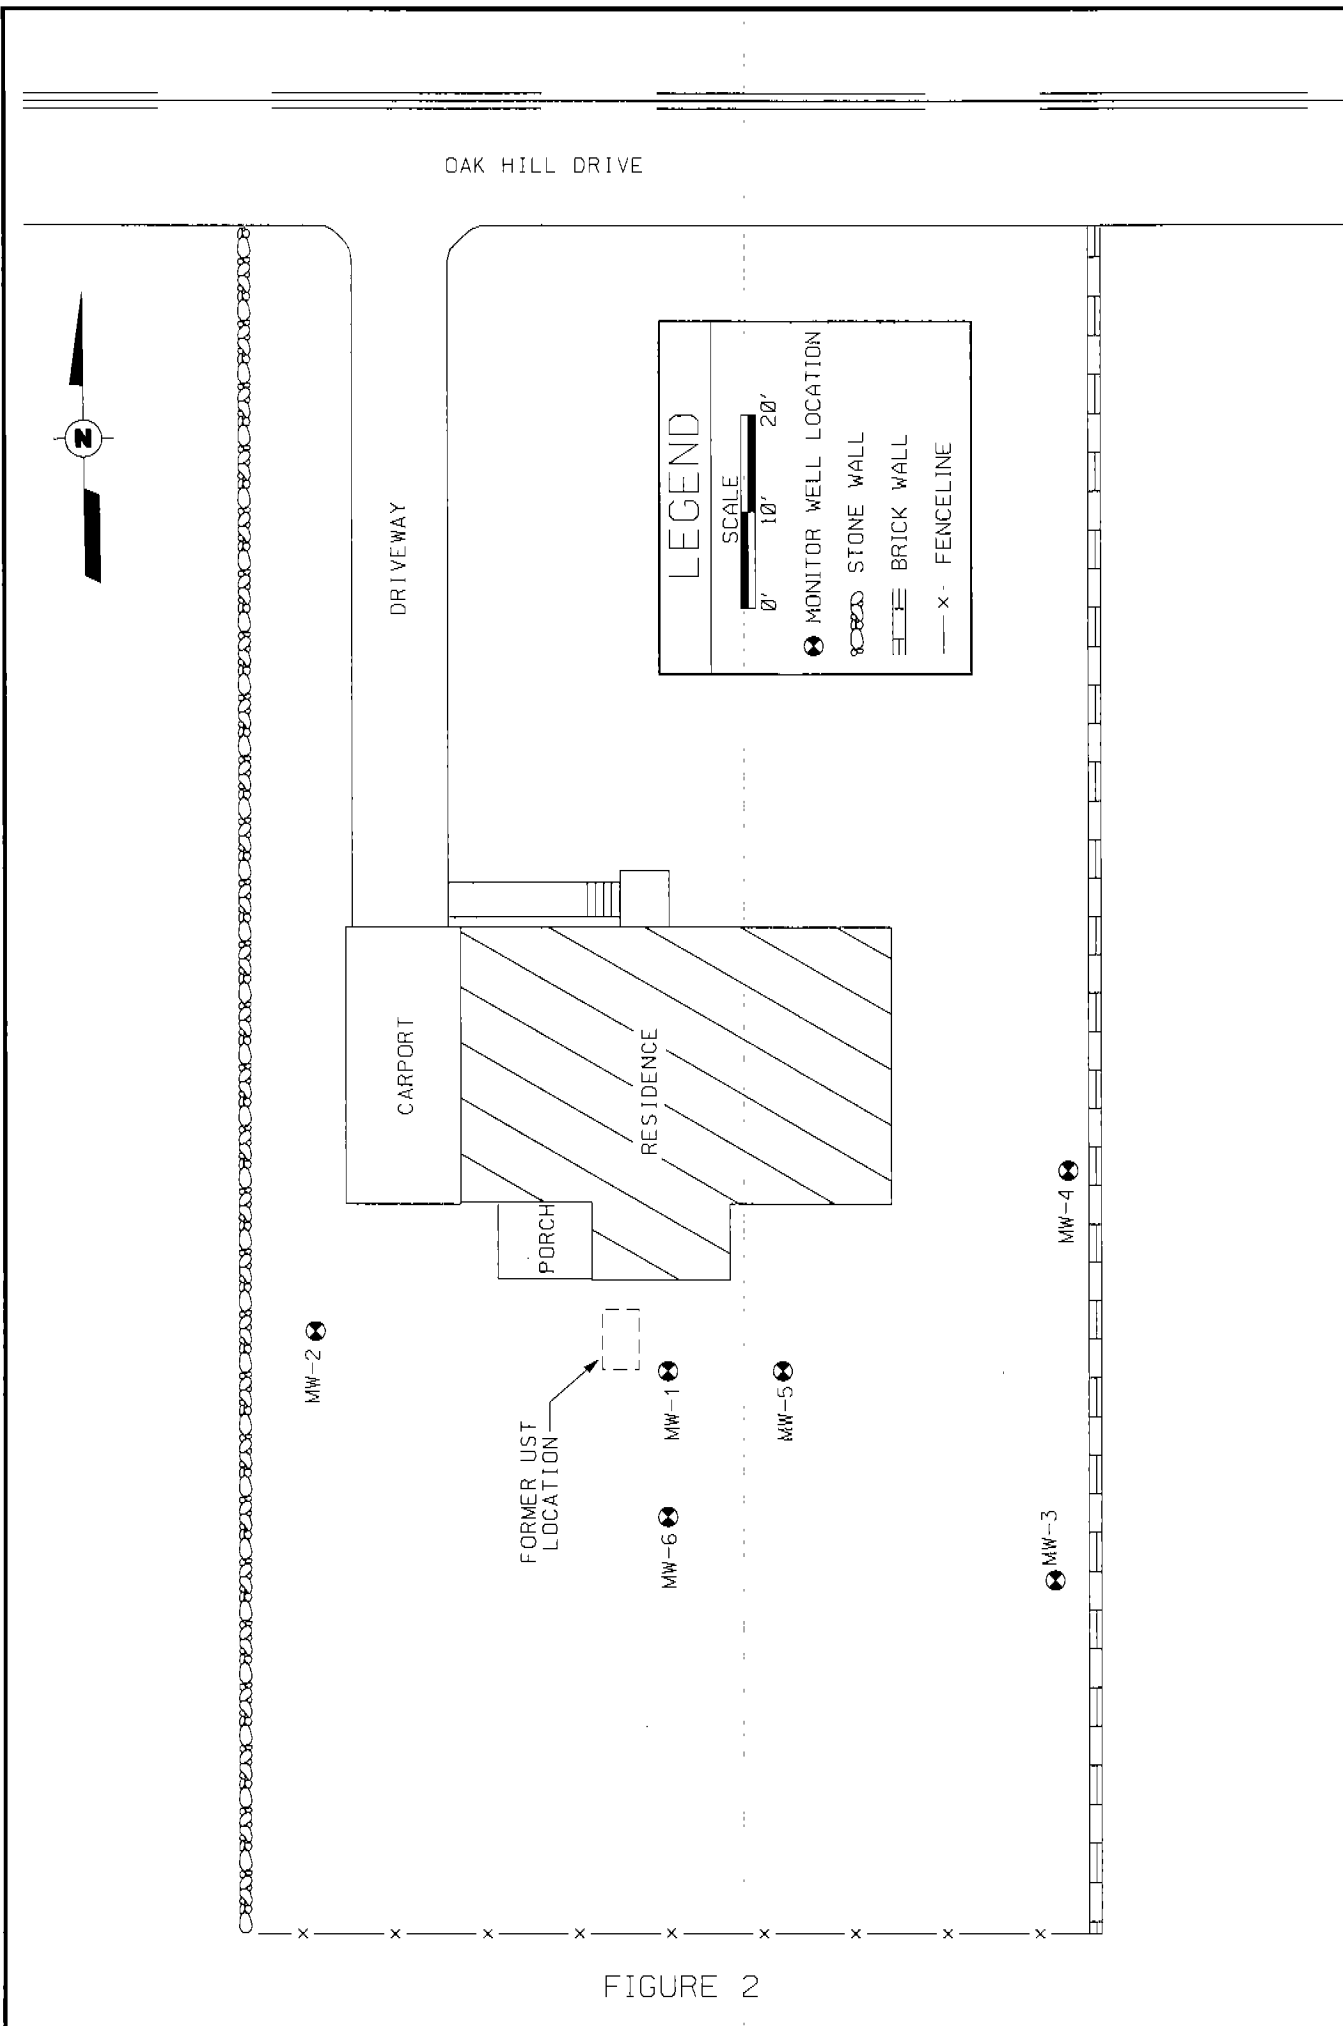
FIGURE 2

SCALE: 1"=20'	TITLE: SITE LAYOUT AND MONITOR WELL LOCATIONS	PROJECT: PRE-CAP MONITORING 2205 OAK HILL DRIVE GREENSBORO, N.C.	CLIENT: MELVIN YARBOROUGH GREENSBORO, NC	LEGACY ENVIRONMENTAL SERVICES, INC. GREENSBORO, NORTH CAROLINA
DATE: 3/12/97				
DWN.BY: KBM				
DWG.# L97-131

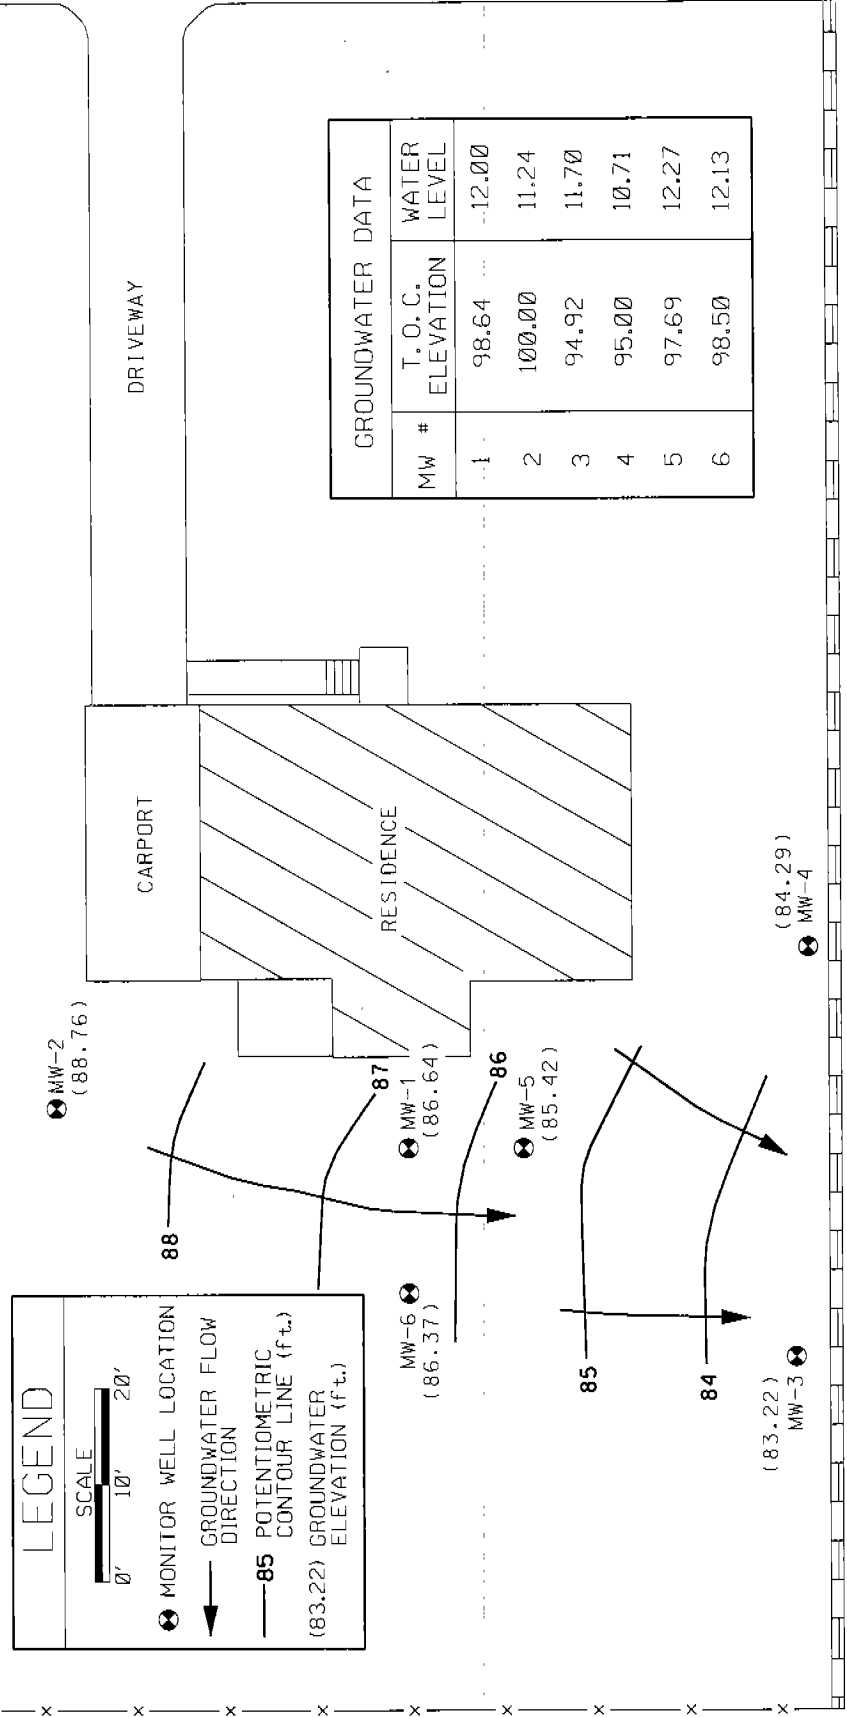
FIGURE 3

In order to estimate the groundwater flow direction in the vicinity of the petroleum release, elevations of the monitor well casings were measured using surveying equipment. Static water levels were then obtained from each of the wells and the data was used to compute a potentiometric surface map which is included as Figure 3.

Groundwater data and monitoring well information, which are summarized in Table 1, were also used to estimate the hydraulic gradient at the project site. Using the horizontal distance between the monitor wells and the static water levels, the groundwater was estimated to be flowing in an eastern direction with a hydraulic gradient of approximately 0.056 ft/ft.

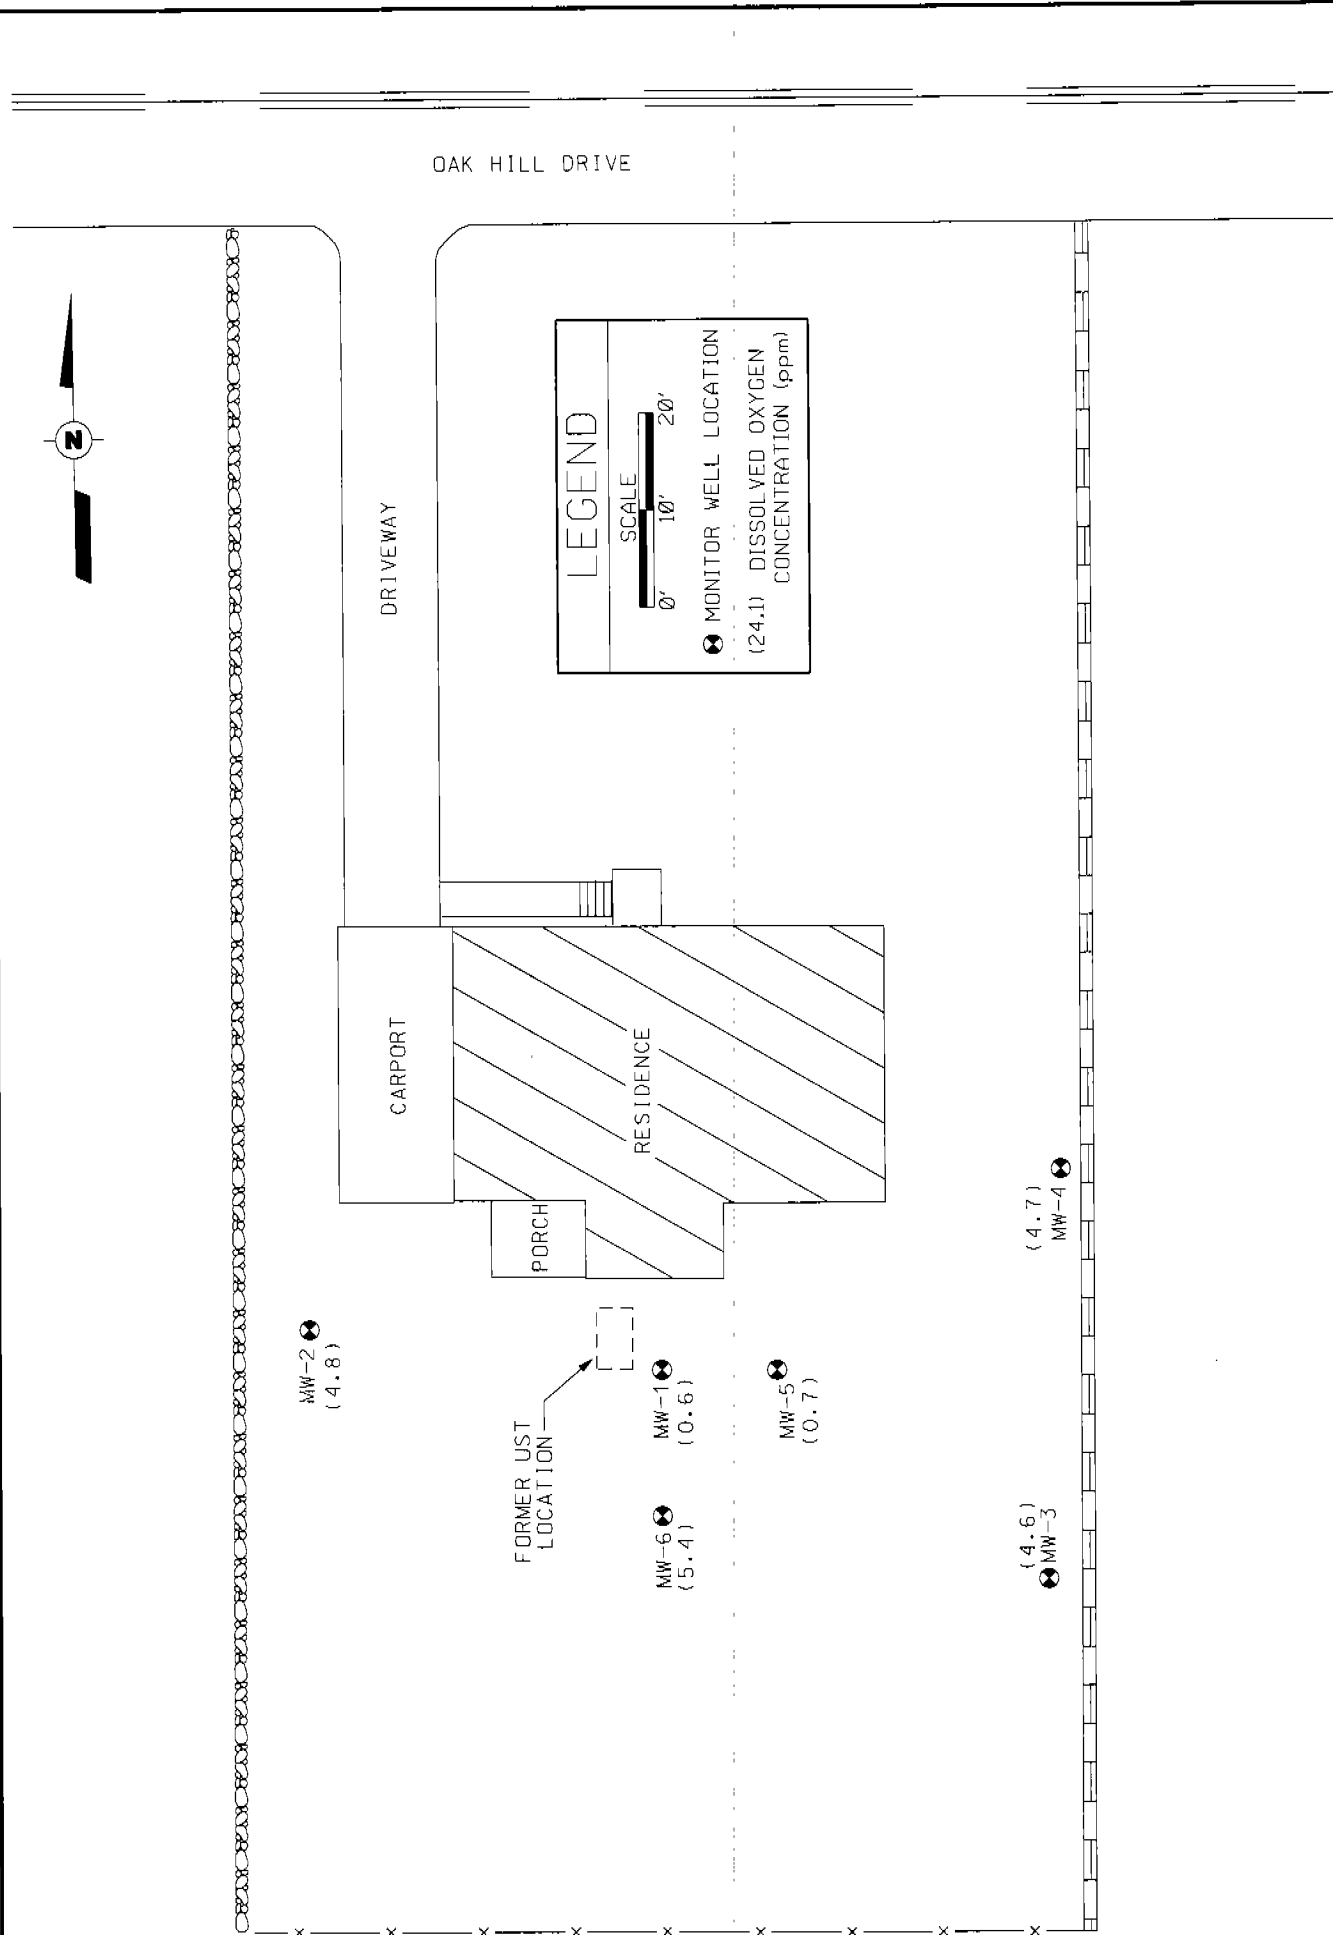
FIGURE 4

To help determine if natural biodegradation is occurring at the project site, the shallow monitor wells in the vicinity of the petroleum release were surveyed for dissolved oxygen (DO) levels. The results of the survey are depicted graphically on the Figure 4 dissolved oxygen distribution map. The results indicate reduced DO levels in the two impacted wells (MW-1 and MW-5), with significant amounts of dissolved oxygen noted in the surrounding wells. The map appears to indicate that natural biodegradation is occurring at the project site.

TITLE:  
 DISSOLVED OXYGEN  
 CONCENTRATION MAP

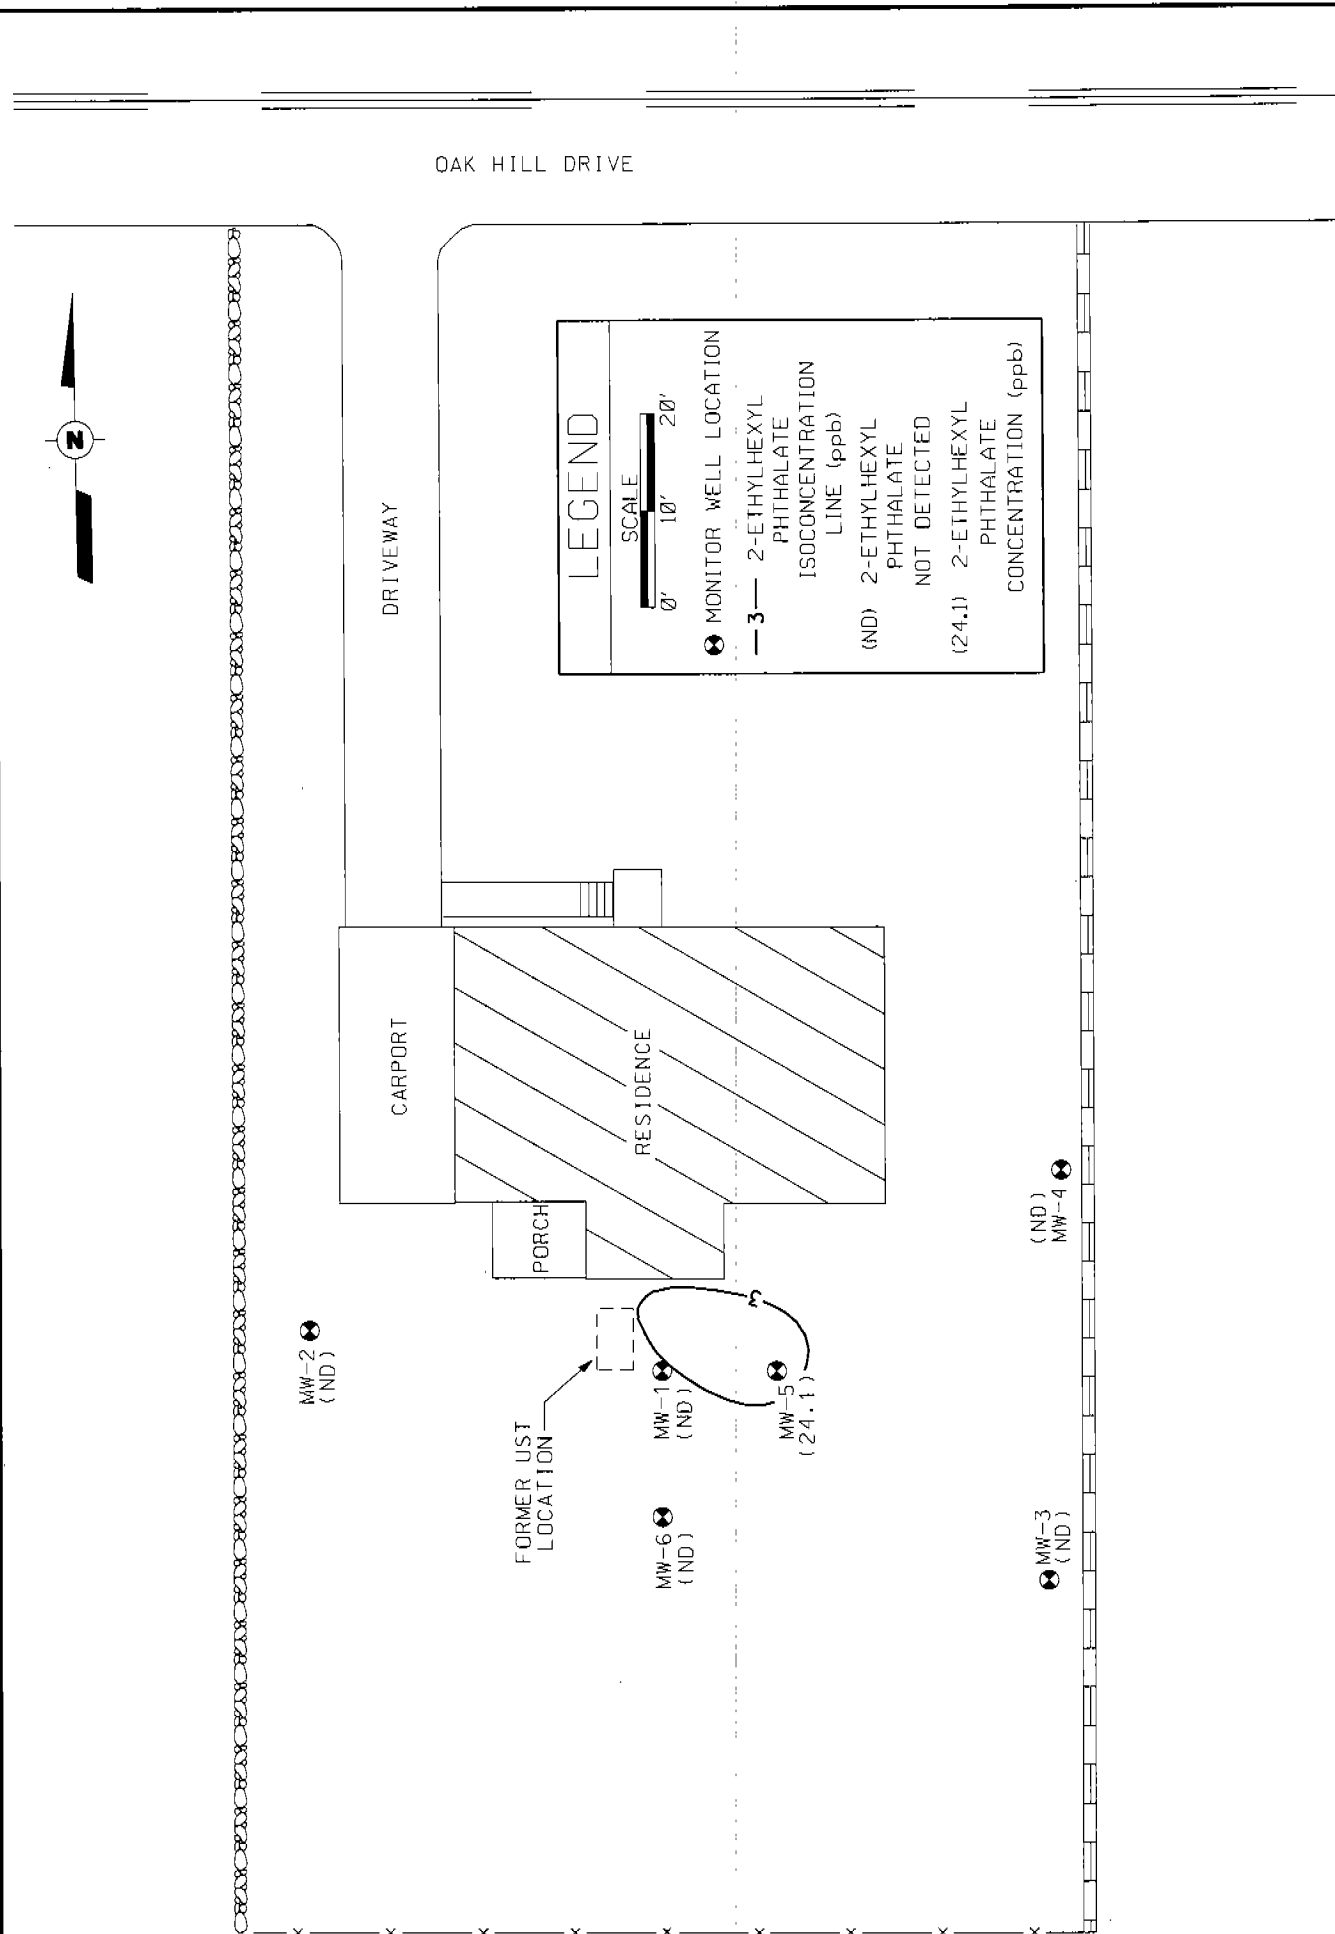
FIGURE 5

Results from the analytical laboratory indicated the presence of one petroleum compound in the groundwater samples above current listed 2L Standards. Benzene, Toluene, Ethylbenzene, and total Xylenes were below their respective 2L Standards in all six monitor wells. 2-Ethylhexyl Phthalate was detected in MW-5 at a level of 24.1 ppb, which is above the 2L Standard of 3 ppb. Naphthalene was detected in MW-1 and MW-5, and Di-n-Octylphthalate was reported in MW-5. The levels detected for these two compounds were below the current 2L Standards. Several Dichlorobenzene compounds were reported in MW-1 and MW-5; however, no 2L Standard has been established for these compounds. No other compounds were detected above laboratory detection limits in any of the monitor wells.

The extent of dissolved petroleum constituents in the groundwater are illustrated on Figures 5 and 6. A 2-Ethylhexyl Phthalate isoconcentration map is included as Figure 5, and Figure 6 contains a total TICs isoconcentration map. Table 2 summarizes the analytical results for the groundwater samples collected on February 24, 1997. A copy of the analytical reports and the chain of custody records for the groundwater samples are contained in Appendix A.

Legacy recommends implementation of a Corrective Action Plan which is currently being prepared by Legacy Environmental Services for 2205 Oak Hill Drive. A copy of this monitoring report should be forwarded to the following address:

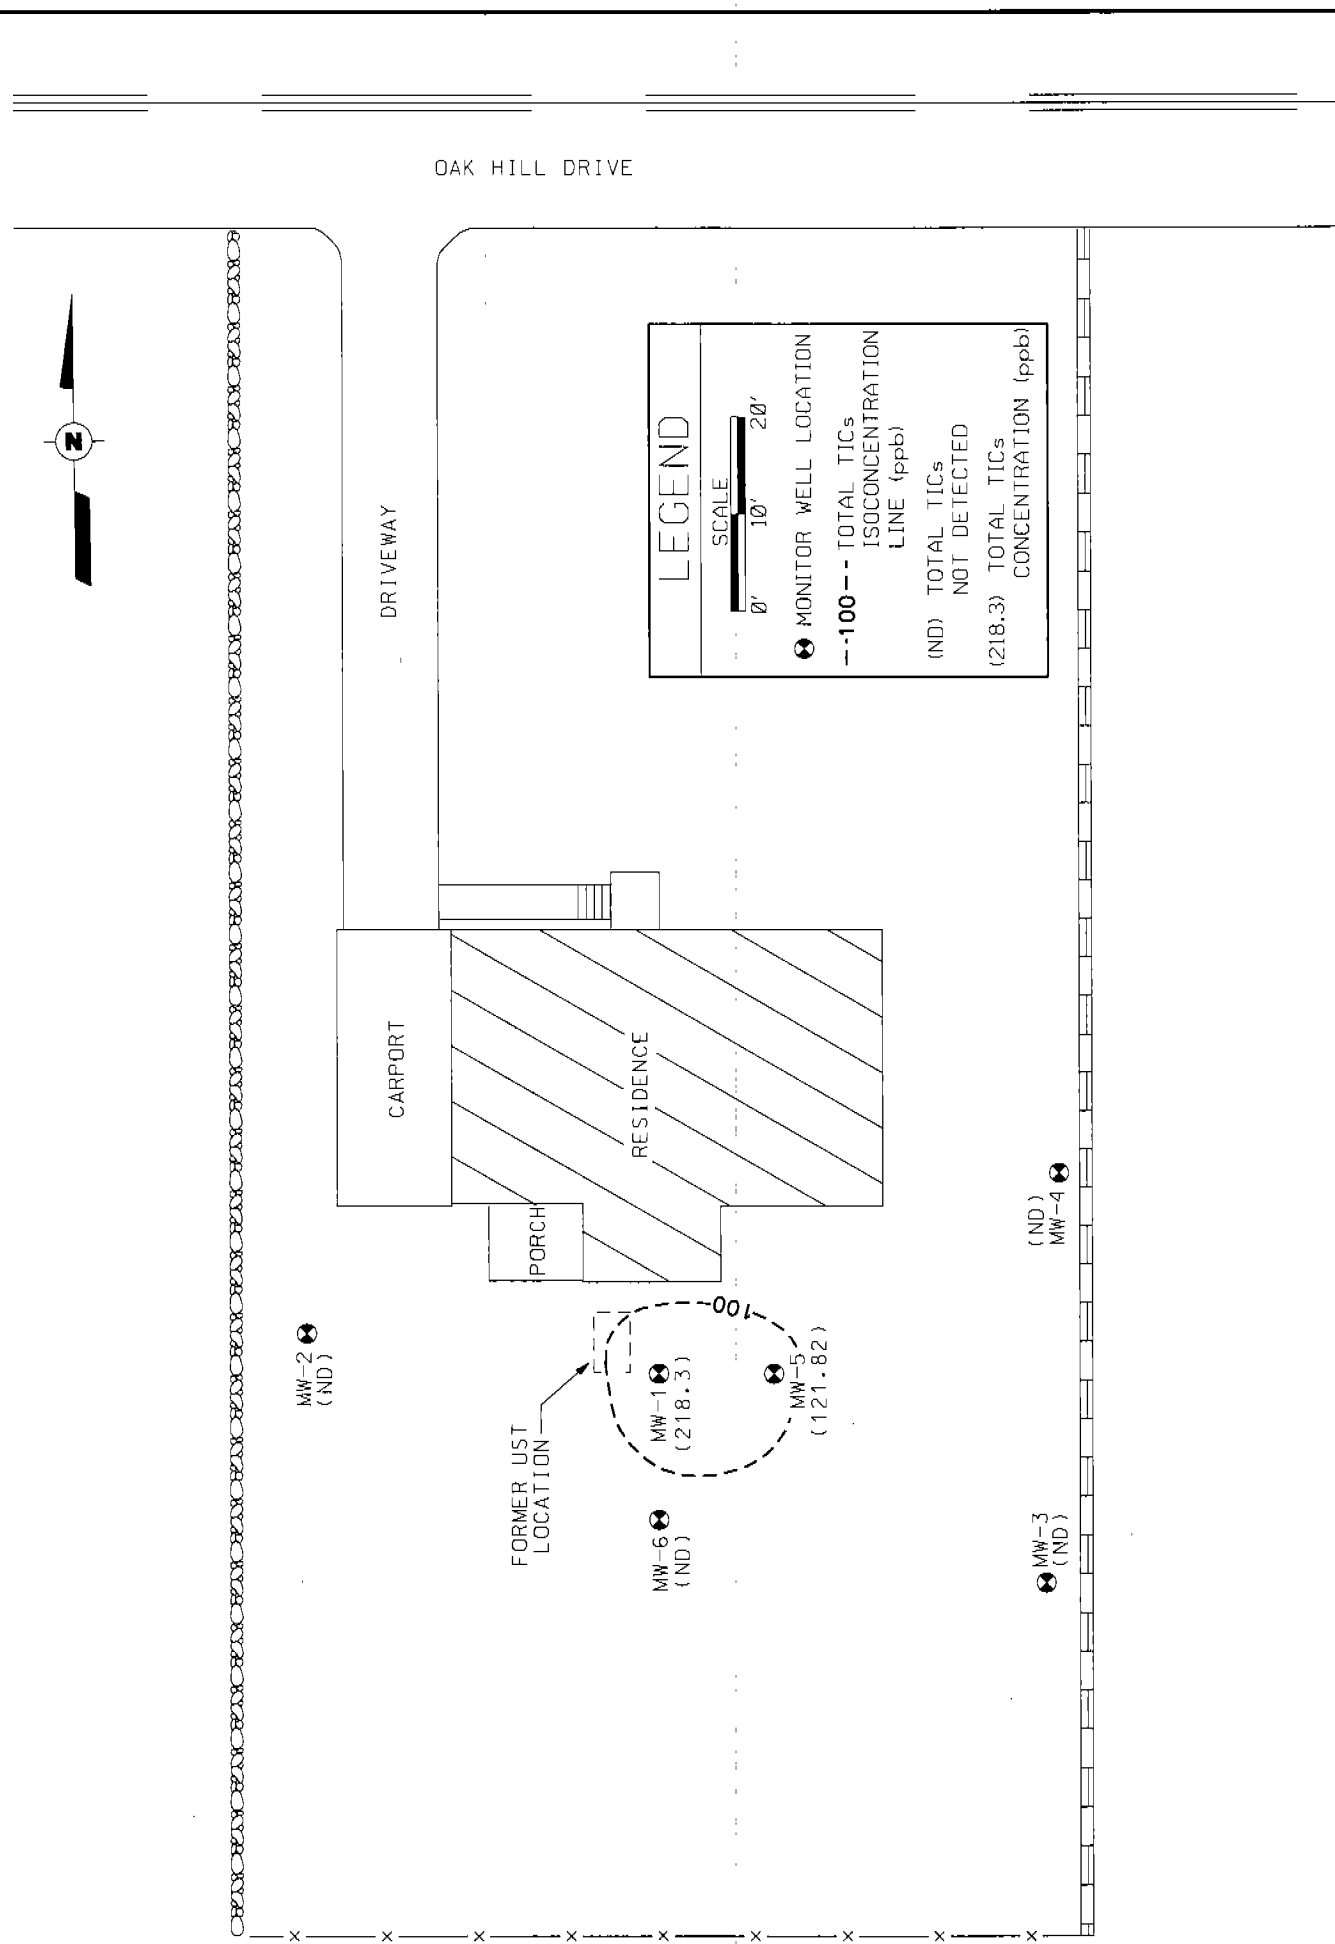
FIGURE 6

Ten tentatively identified compounds (TICs) were detected in MW-1 with a total concentration of 218.3 ppb, and MW-5 showed a TIC total concentration of 121.82 ppb. No TICs were reported in any of the other four monitor wells at the site. TICs currently do not have a 2L Standard.

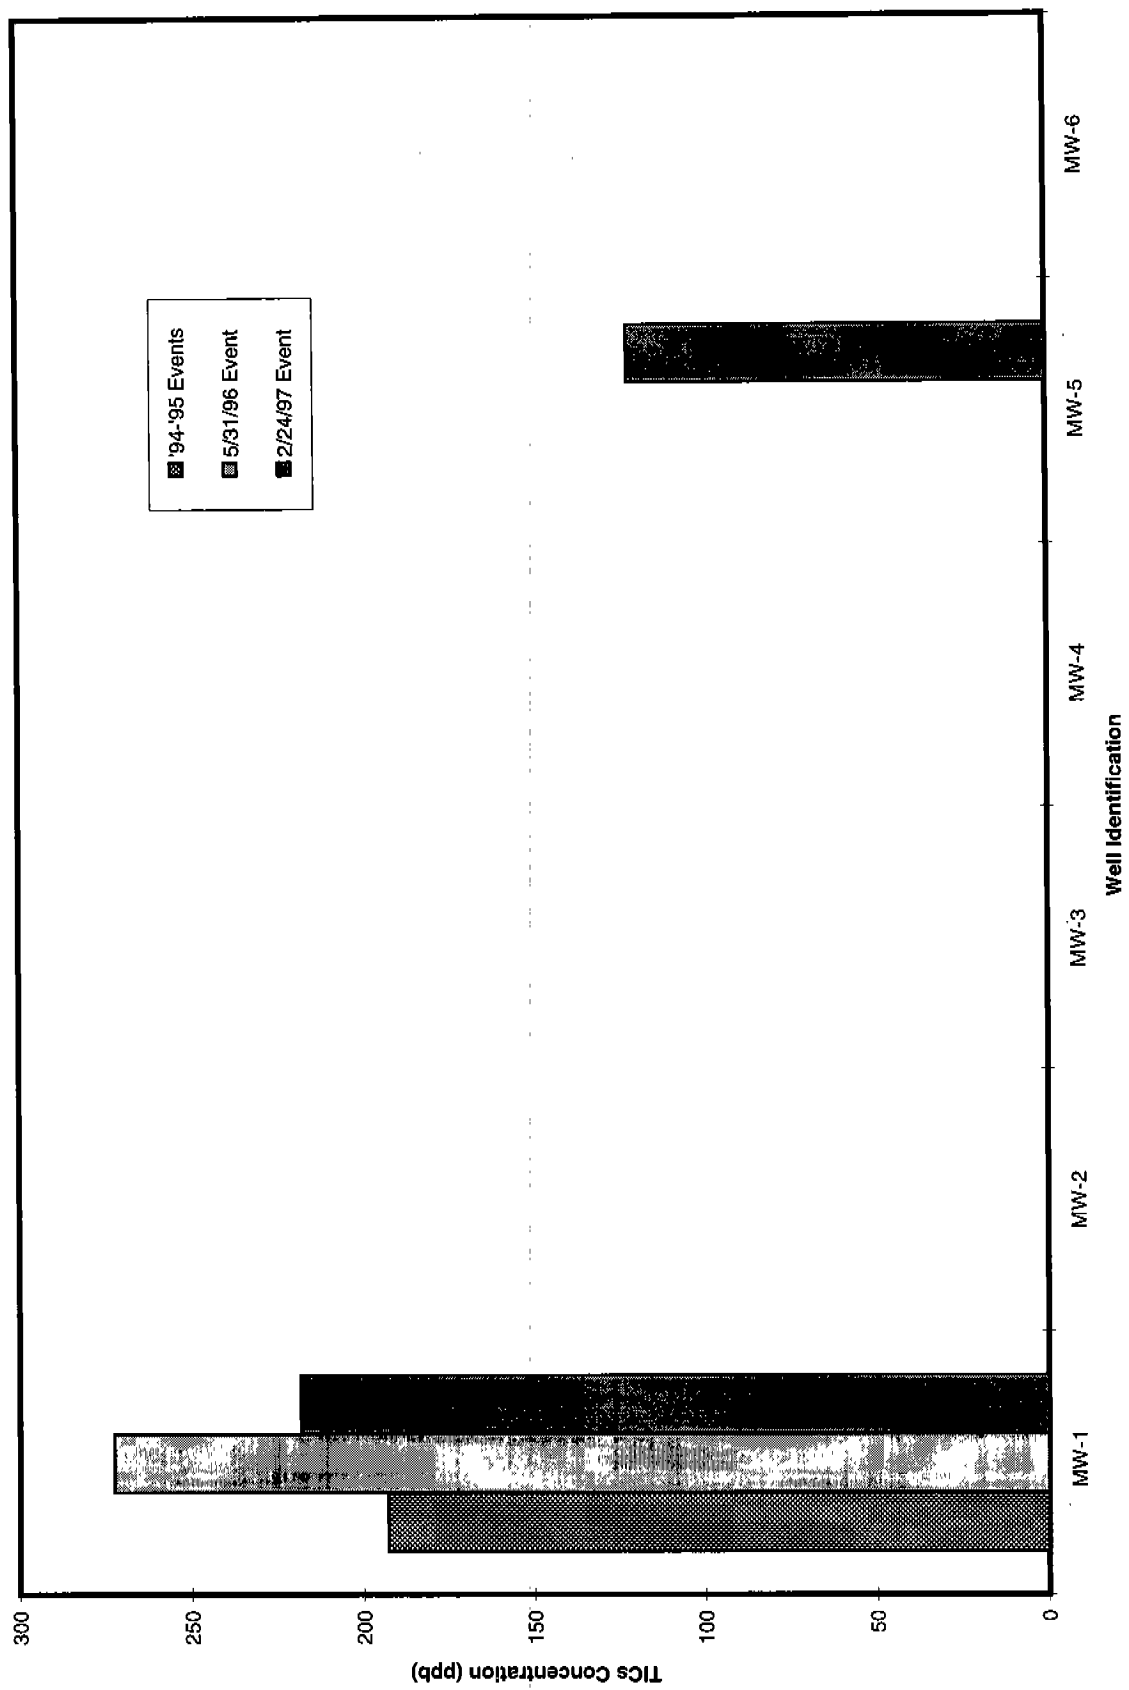
FIGURE 7: Total TICs Concentration vs. Time

Total BTEX concentrations have shown no change in concentration since the May, 1996 sampling event. BTEX levels were below 2L standards for all wells during both sampling events. However, Tentatively Identified Compounds have increased in concentration in MW-5 since the previous sampling event. During the May, 1996 sampling event MW-1 was the only well showing a detectable TICs concentration, but during the sampling event on February 24, 1997, TICs were detected in MW-5 at a total concentration of 121.82 ppb. 2-Ethylhexyl Phthalate was also detected in MW-5 on February 24, 1997; this compound was not previously detected at the site. Table 3 contains the time based analytical results for Total TICs, and Figure 7 illustrates the same information graphically. The figure and graph referenced above indicate that the contaminant plume at 2205 Oak Hill Drive is migrating down-gradient toward MW-5.
